ROCK SLOPE STABILIZATION

TSP 67-1
TACONIC STATE PARKWAY
(KITCHAWAN ROAD-BALDWIN ROAD)
WESTCHESTER COUNTY

SUBJECT TSP 67-1, TACONIC STATE PARKWAY, KITCHAWAN RD. TO BALDWIN RD.
WESTCHESTER COUNTY, PIN 8107.00-301, RECOMMENDATIONS FOR
REMEDIAL TREATMENT OF ROCK SLOPES

SUBJECT TSP 67-1
TACONIC STATE PARKWAY (KITCHAWAN RD. - BALDWIN RD.)
WESTCHESTER COUNTY, P.I.N. 8107.00-301

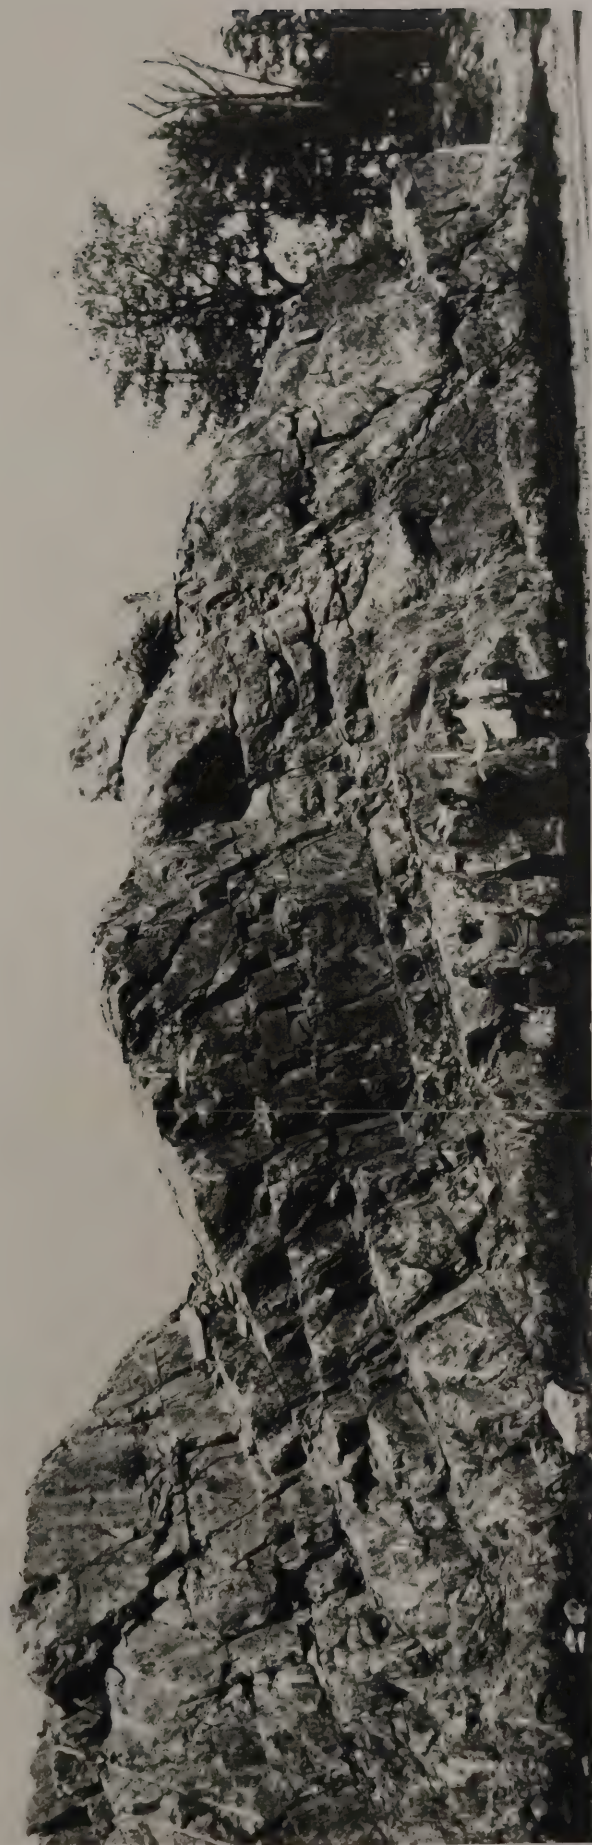
Figure No. 1 Stations S367+50+ to S369+00+, right.

- b) The east slope of the Southbound, Stations S367+50₊ to S369+00₊, right (see Figure No. 1).

(Note fallen rock on shoulder)

The area should be re-scaled and all loose stone removed. Due to the blocky nature of the rock excessive heavy scaling should be avoided to prevent a condition similar to that which has already occurred on the Northbound. (See Section 2c and Figure No. 3)

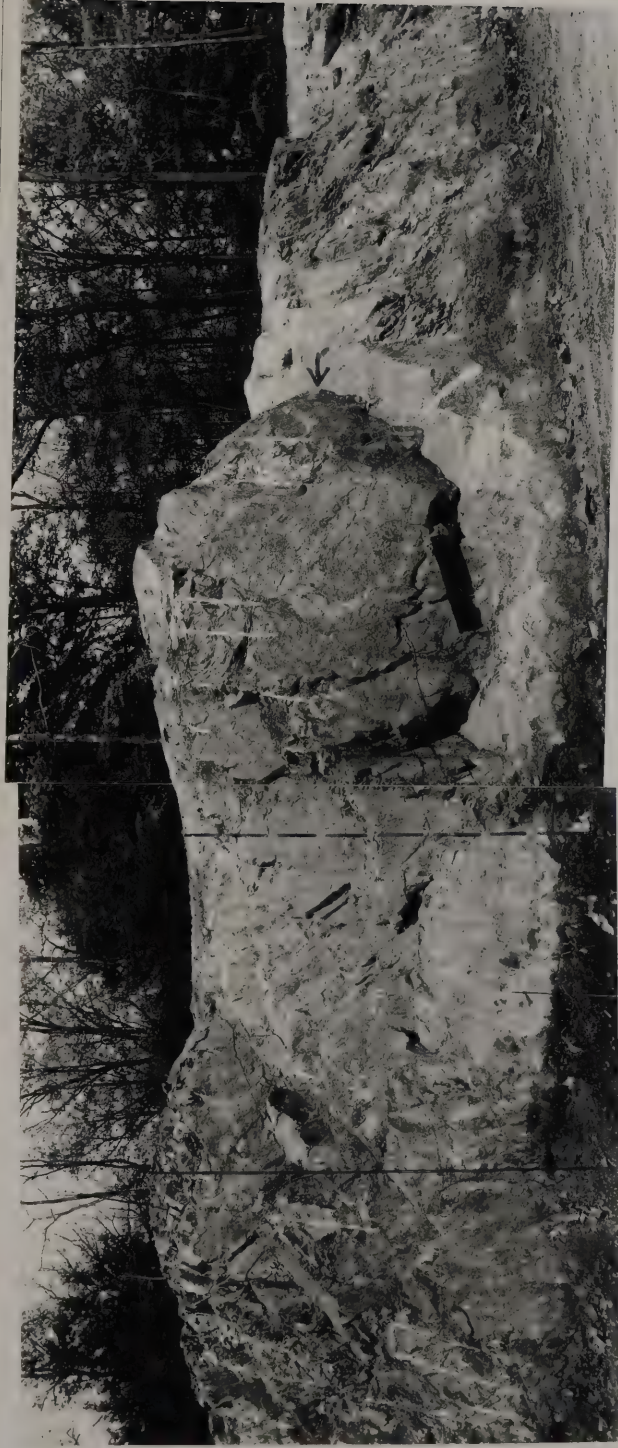
- b) "NE" Ramp Stations 10+70 \pm thru 11+15 \pm , right (see Figure No. 2).

A large mass of rock rests on a natural joint plane which dips toward the Northbound Lanes at an inclination of one vertical on one horizontal. Between "NE" Ramp Stations 10+70 \pm and 10+90 \pm , right, holes should be drilled on a one on one slope along a line formed by the intersection of the joint plane and the existing ground surface behind the mass. Beginning at "NE" Ramp Station 10+90 \pm , right, the drilling angle should gradually be steepened to meet the two vertical on one horizontal slope at "NE" Ramp Station 11+15 \pm , right.

Figure No. 2 "NE" Ramp Stations 10+55± to 11+25±, right. Rock should be presplit on a one on one slope starting at Station NE 10+70+ (arrow at right of photograph) to NE 10+90+ (dashed vertical line, center of photograph). Drilling angle shall be gradually steepened to a two vertical on one horizontal slope at Station NE 11+15± (solid vertical line, left of photograph).

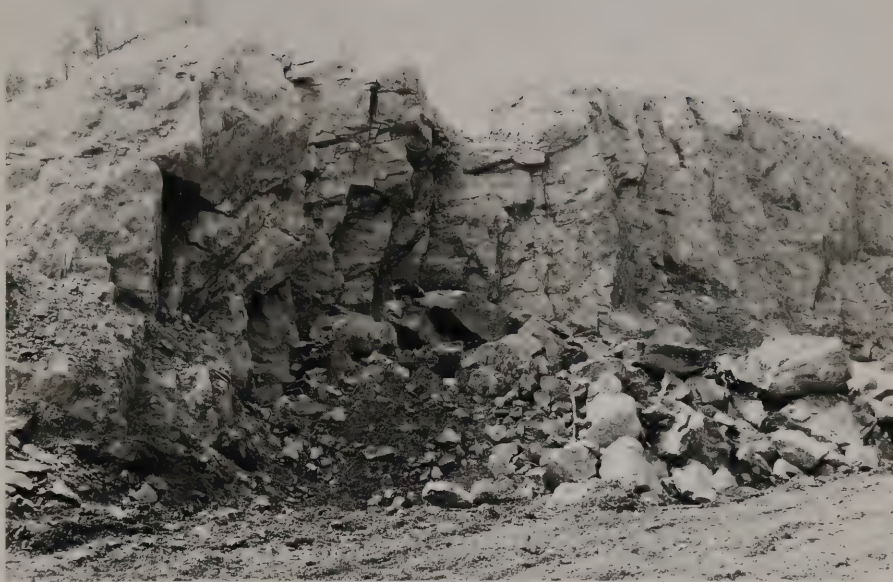
Figure No. 3 - Northbound Stations N373+00+
to N374+00+, left.

- c) The "nose" of rock between the Northbound and Southbound Lanes at Stations N373+00 \pm and N374+00, left (see Figure No. 3).

Blasting in this area caused excessive breakage of the rock in the lower portion of the slope and as a result undermined the upper slope. The Contractor attempted to remove the overhanging rock by scaling. Due to the blocky nature of the rock, additional unstable rock became exposed on the upper slope as the scaling progressed. It is recommended that all loose stone be removed from the area with care taken to avoid removal of any rock which is keyed into the toe.

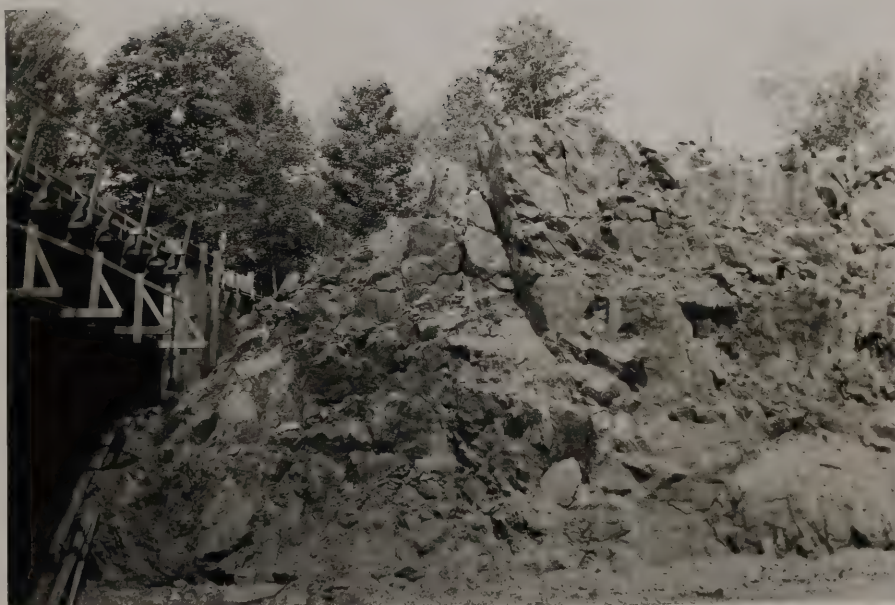
Figure No. 4 - Northbound Station N414+00+,
right.

- d) Northbound Station N414+00 \pm , right (see Figure No. 4).

This area will require heavy scaling to remove the large blocks of rock which lie on a joint plane dipping steeply toward the Northbound Lanes. On April 30, 1969, Mr. J. Howe of the Bureau of Soil Mechanics made the recommendation that this rock should be re-drilled and shot prior to the construction of the east abutment of Bridge No. 6. This is documented in the Project Diary. The Contractor was informed of this recommendation but chose to ignore it.

The heavy scaling recommended for this area would have been unnecessary had Mr. Howe's recommendation been followed.

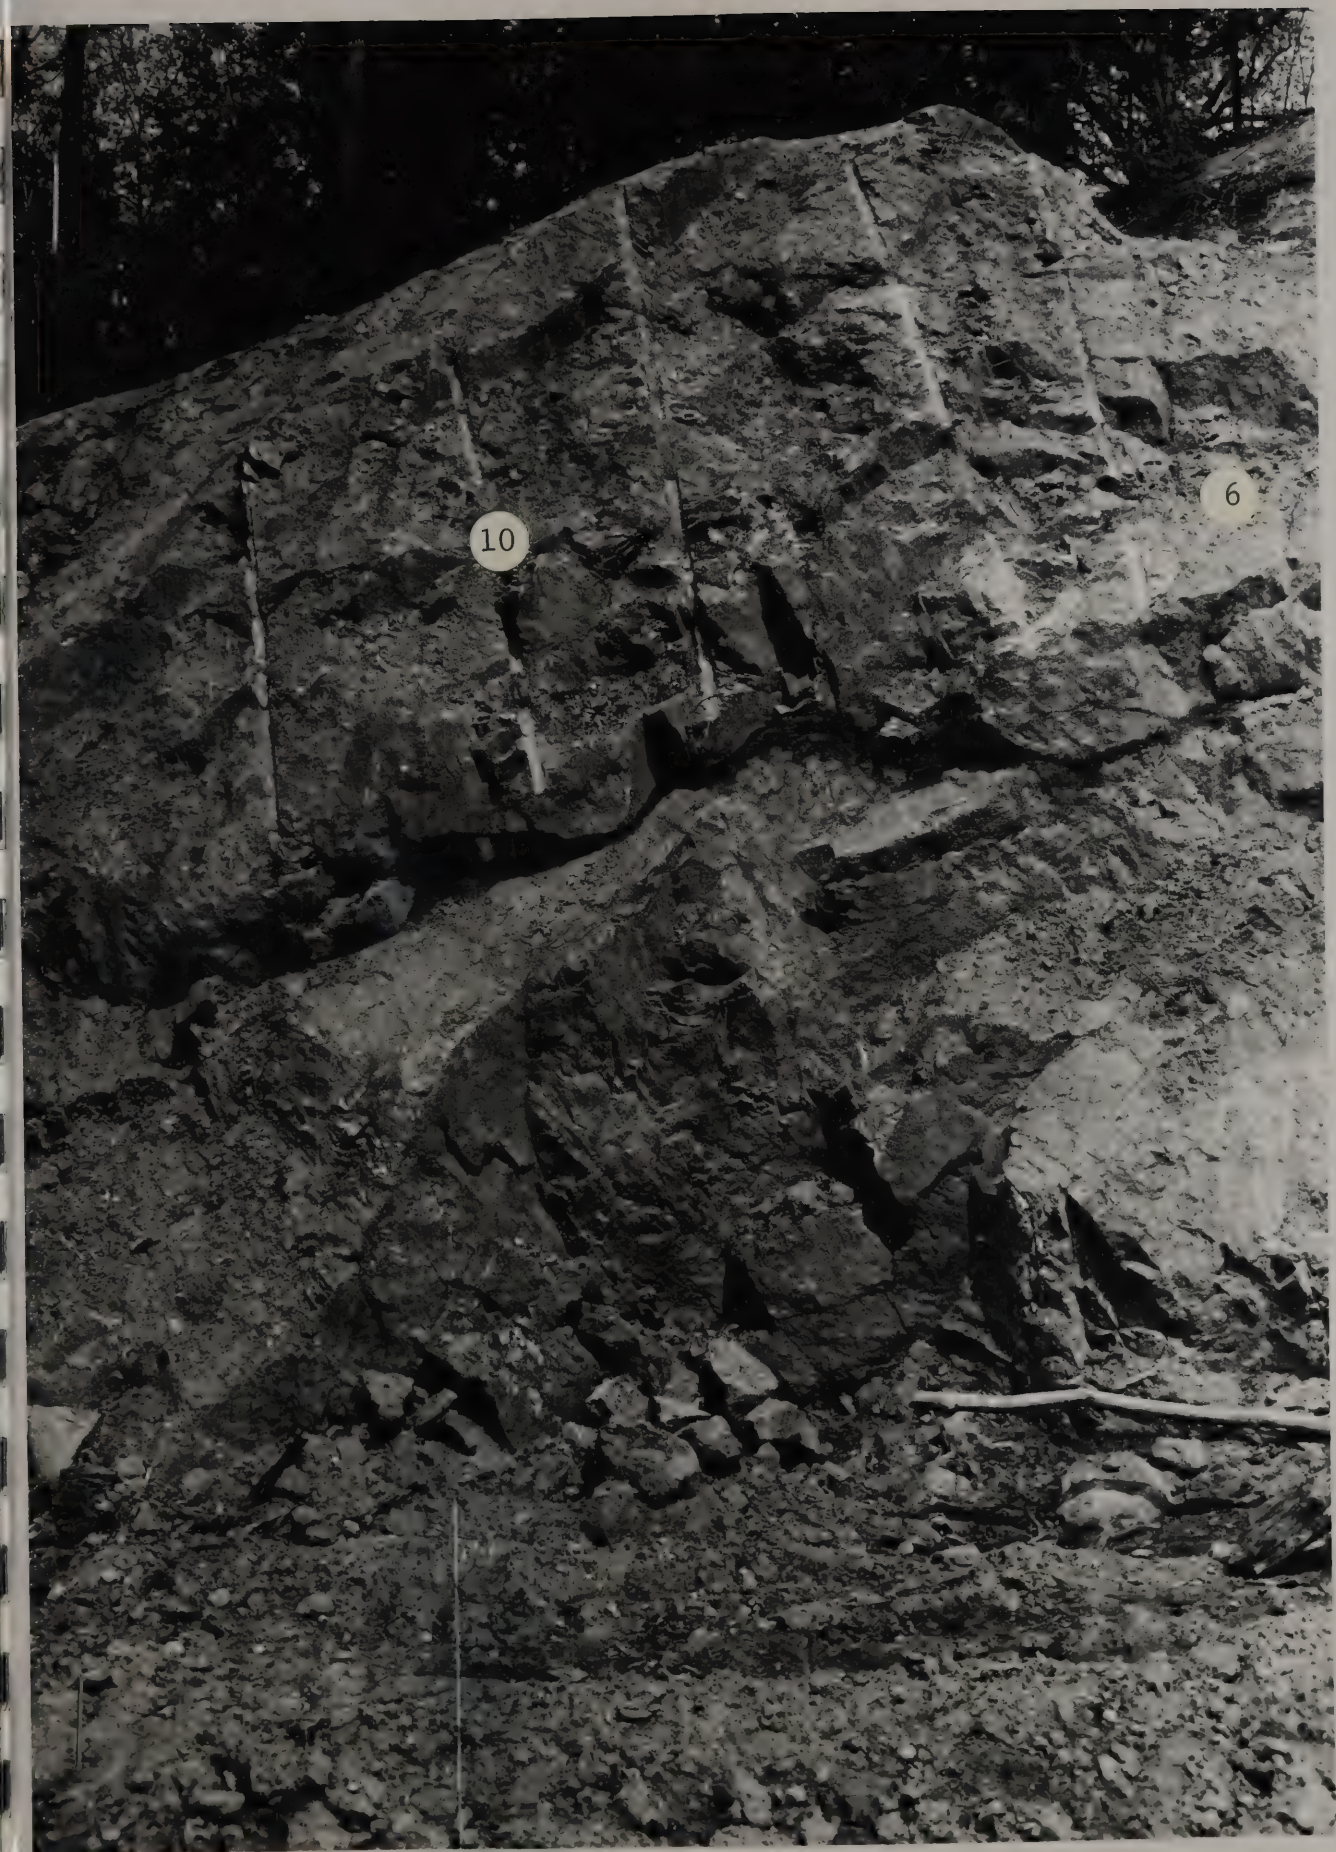
Figure No. 5 - "NE" Ramp Station 9+65 \pm , right.

It was concluded that 46 linear feet of rock bolts (6 bolts, six feet in length and 1 bolt, ten feet in length) would be required to stabilize the rock slopes examined on May 20, 1971. The locations of 4 of the bolts are illustrated in Figures No. 5 and 6.

Rock Bolts

Installation of the rock bolts shall in all cases be normal to the joint plane surface underlying the rock to be bolted.

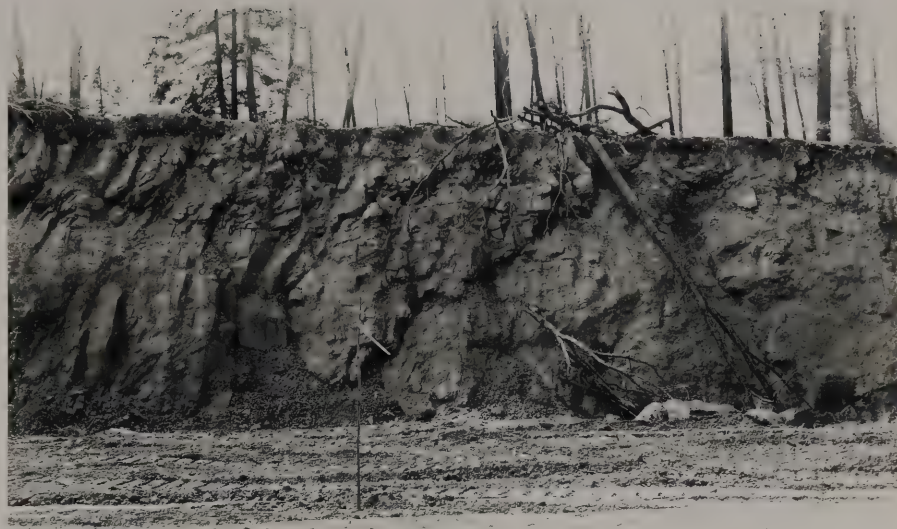
Figure No. 7 - Northbound Station N378+00 \pm , left.

- e) Northbound Stations N377+00₊ through N379+00₊, left (see Figure No. 7).

This rock slope consists of badly weathered rock of a blocky nature which falls within the limits of the widening area (see Page 4, Paragraph 2). Continued exposure of this rock will result in the formation of a talus pile at the toe of the slope. This slope should be thoroughly scaled to minimize maintenance costs.

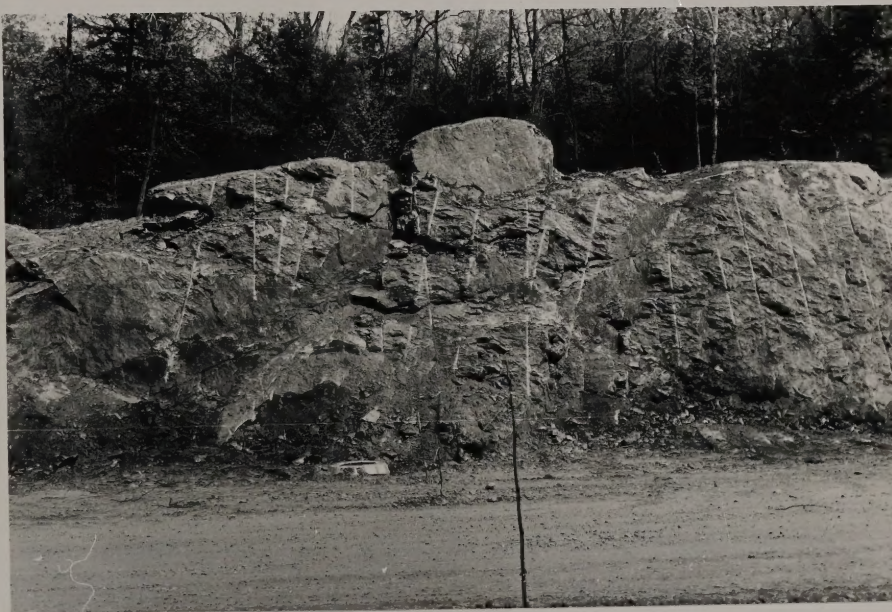
The extensive amount of remedial treatment required to stabilize the rock slopes on this project infers that rock of poor quality was encountered and/or the drilling and shooting was poorly controlled. It is true that there is some badly jointed, blocky and weathered rock on the contract, however, proper drilling and shooting methods would have greatly reduced the problems. Mr. V. Bryant's report of January 21, 1971, made note of the fact that under similar rock conditions, areas where presplitting was and was not required showed no appreciable difference in results. He stated, "It appeared that the same procedures were followed whether presplitting was required or not." He further stated that, "Evidence points to the fact that since the Contractor was permitted to deviate from the specification in some areas, operations in other areas where presplitting was required were less than satisfactory." These statements are illustrated in Figure Nos. 8 through 12. At locations shown in Figure Nos. 8 and 9, the presplitting requirement had been waived. At locations shown in Figure Nos. 10 and 11, however, the presplitting requirement was in effect. Figure No. 12 is taken at Station equality N378+00+ = "NE" Ramp Station 13+14+, right. This photograph was taken in the transitional region between areas where presplitting was and was not required. In the left third of the photograph, presplitting was required. In the right third of the photograph, the slope is more uniform

even though it was not presplit according to specifications. In this case, the Contractor inadvertently maintained better control of the drilling and as a result produced a more uniform rock slope.

Figure No. 12 - Northbound Station N378+00₊, right.
Note that the inadvertently well aligned drill holes on the right side of the photograph produced a uniform plane of rupture. Poorly aligned holes in the center and left side of the photograph produced a ragged and uneven slope.
